Project name Ayrton Senna Highway, SP-070

Location São Paulo, Brazil

**Objective / Initial position** Double the durability of the road in challenging conditions to reduce costs, traffic obstruction and the use of resources

### **Project description**

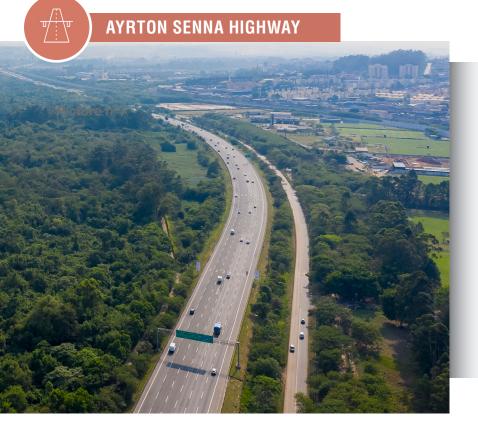
S&P asphalt reinforcement grid laid onto bitumen tack coat

On 18th/19th April 2011, S&P asphalt reinforcement grids were installed on various sections on lane 4 of the highway. Since the various sections had differing levels of stability and damage, the grid and wearing course combinations were recommended by S&P based on the severity of the damage pattern. These sections can be seen below:
